Barn / Guest House

Site Review Comments: 11/30/2010

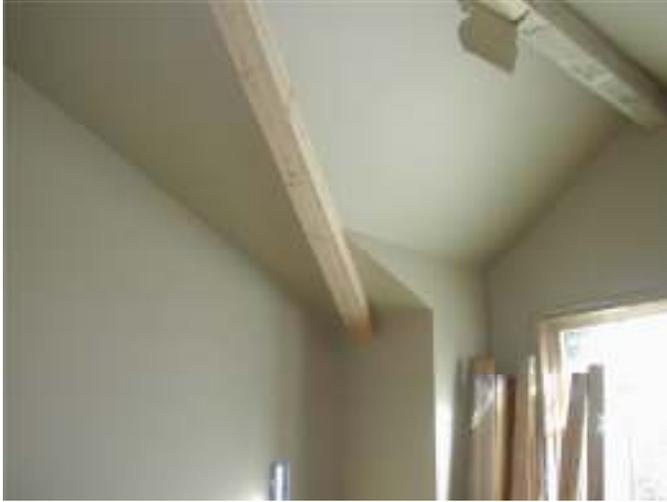
Diagonal Beam in Bedroom #2.

4. Ceiling beams look great. Keep up the good work
